# Manhole Inspection Summary

Manhole # S51G\_\_002MH

Insp Date: **9/17/08 10:28 AM**

**Location** Address: **100 patterson park**

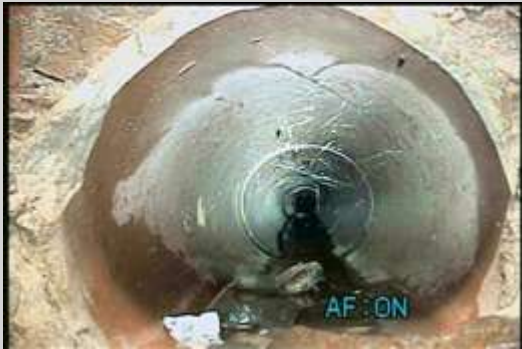
12 O'Clock Outflow

10 in. Circular Gravity Sewer  
Pipe Out @ 12 O'Clock

Pipe Material: **Clay** ☐ Pipe Lined

Invert Depth: **5.75** (ft.) Flow Characteristics: **Slow**

Deposits: ☒ None ☐ Mud ☐ Sludge ☐ Debris ☐ Grease

Infiltration: **None** Pipe Seal Cond: **Unknown**

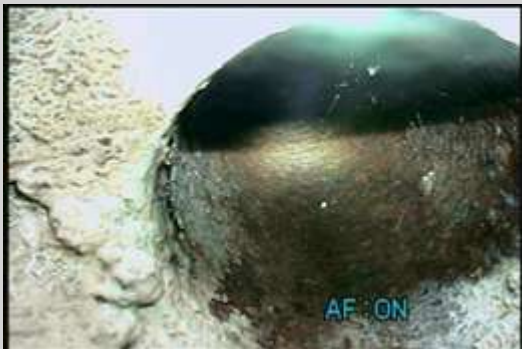
3 O'Clock Inflow

6 in. Circular Gravity Sewer  
Pipe In @ 3 O'Clock

Pipe Material: **Clay** ☐ Pipe Lined

Invert Depth: **5.58** (ft.) Flow Characteristics: **Slow**

Deposits: ☒ None ☐ Mud ☐ Sludge ☐ Debris ☐ Grease

Infiltration: **None** Pipe Seal Cond: **Unknown**

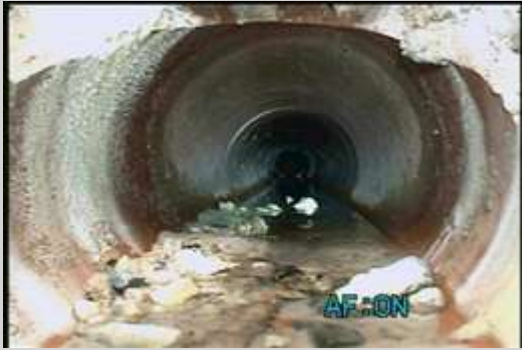
6 O'Clock Inflow

10 in. Circular Gravity Sewer  
Pipe In @ 6 O'Clock

Pipe Material: **Clay** ☐ Pipe Lined

Infiltration: **None** Pipe Seal Cond: **Unknown**
